WOODLAND RESERVOIR DAM

PHASE I INSPECTION REPORT

NY 00412

Date of Inspection June 5, 1978

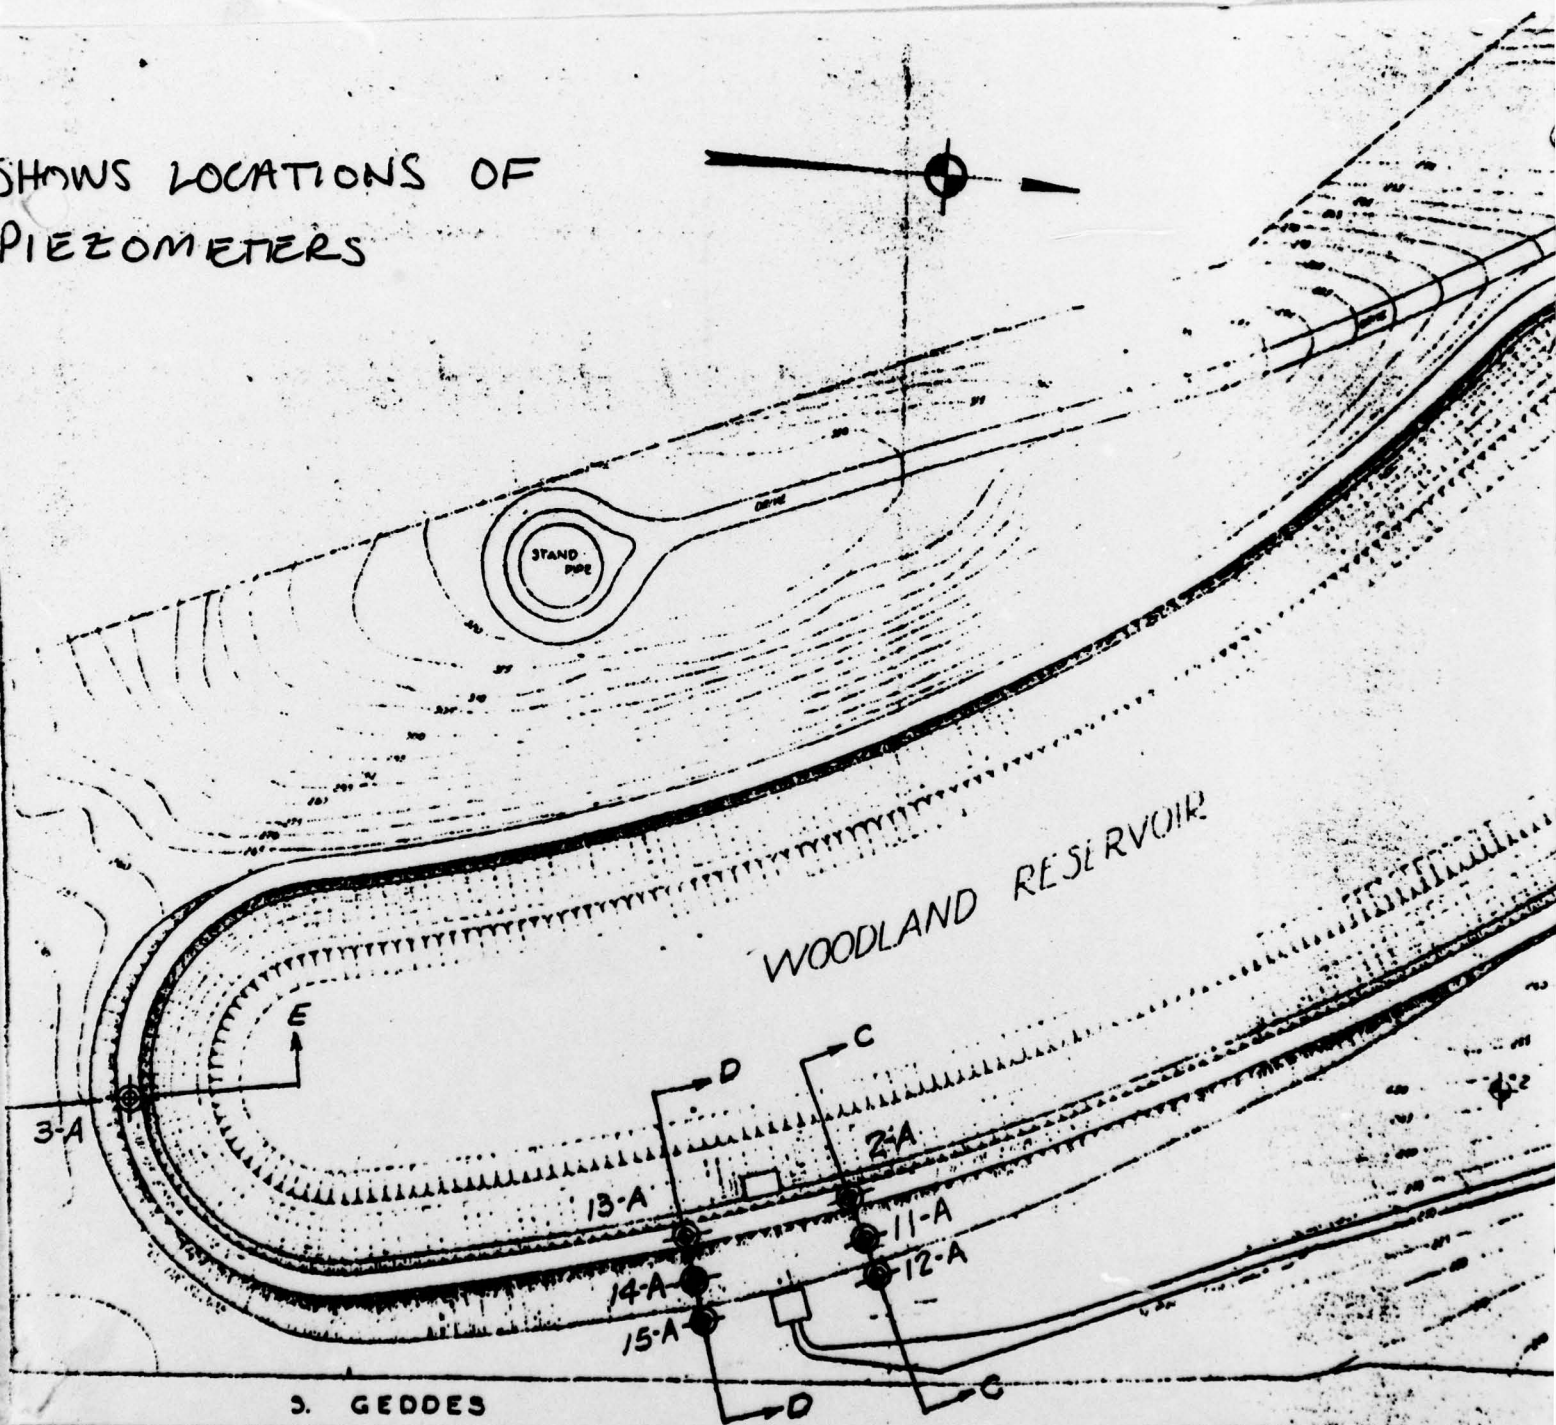
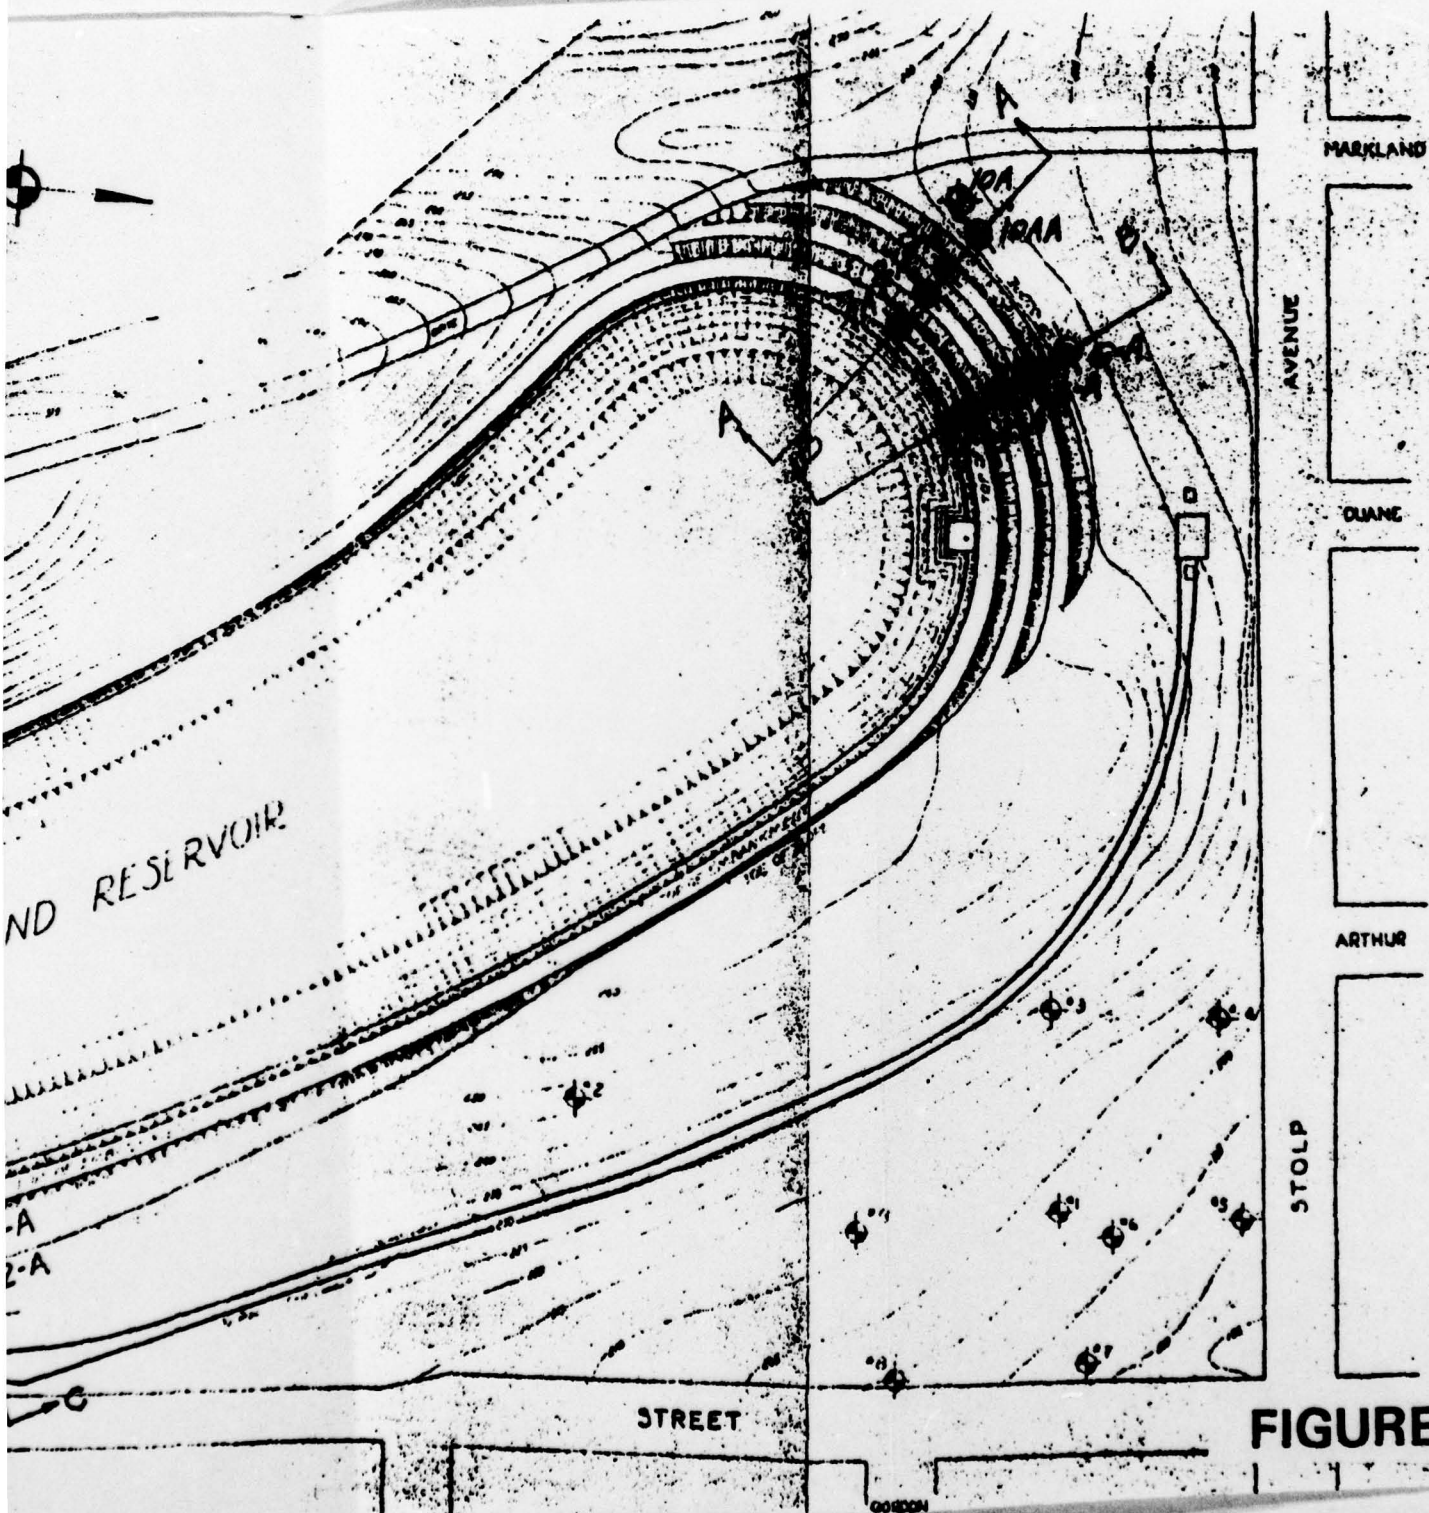
FIGURE 2

Existing site topography* and orientation of the reservoir are shown in Fig. 2. Construction drawings indicate that the site was originally a saddle from which the flow of surface water was respectively to the north and the south. The reservoir was formed by making an excavation in the saddle area and utilizing the excavated material to construct dikes at either end. It appears that there was an approximate balance of cut and fill and that all embankment material was obtained from the site. Thus the reservoir bottom and all cut and embankment slopes are in or of essentially the same material. This material is glacial till as is more fully described in later sections of this report.

In March 1964, borings were made in the northeasterly corner of the property to investigate conditions affecting construction of the proposed Southwest Junior High School. These were designated borings #1 to 9 inclusive. Their locations are shown in Fig. 2. While this investigation did not include examination of the reservoir embankments, it provided information on certain site features of interest in this report. For this reason, the driller's logs of these borings have been included in Appendix 1.

The purpose of the investigation undertaken by the writer was to determine the nature and condition of the materials in the reservoir embankments and the embankment foundations. Although the initial plan was to make this investigation by means of both test pit excavations and borings, agreement was reached with the City Engineer during the course of the work that borings alone would be sufficient. Fifteen borings designated 1-A to 15-A inclusive, were eventually made at locations shown in Fig. 2. The driller's logs of all these borings will be found in Appendix 2 of this report.

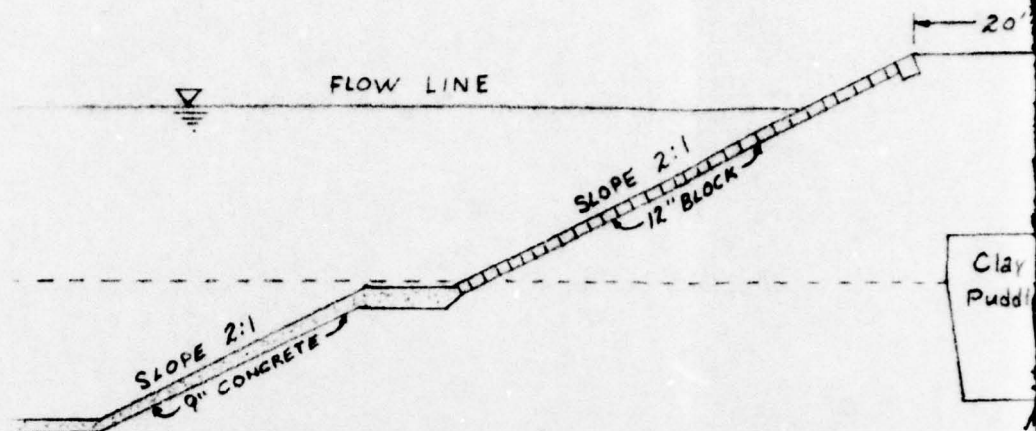
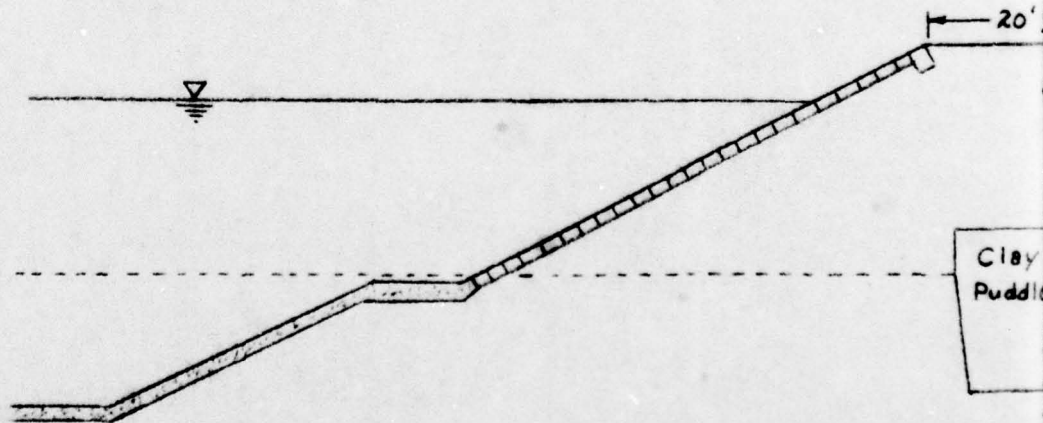
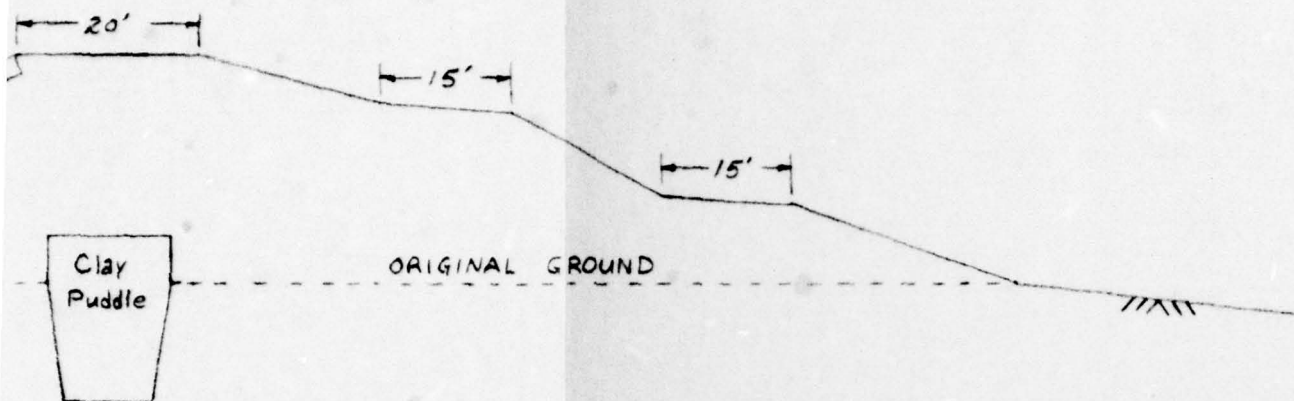
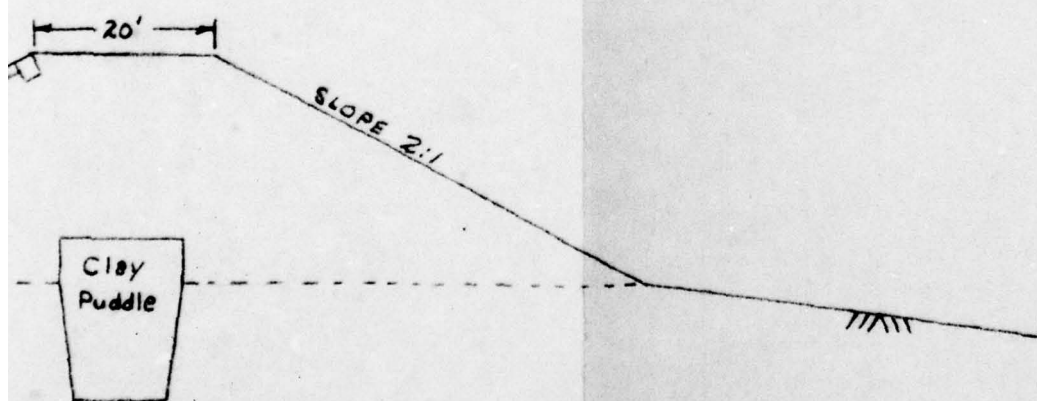
FIGURE 3
TYPICAL SECTIONS

According to the design drawings (See Figure 3), by Howard Soule, Consulting Engineers, Woodland Reservoir Dam is a homogeneous, rolled earth embankment with an impervious clay puddle cut-off trench. The upstream slopes of the dam and bottom of the reservoir are protected by a concrete lining. The visible portion of the upstream face of the dam has a slope of 2 horizontal to 1 vertical and is paved with limestone blocks set in the concrete lining. The blocks extend below the water surface to a 10-foot berm which is located 26 feet below the top of the dam.

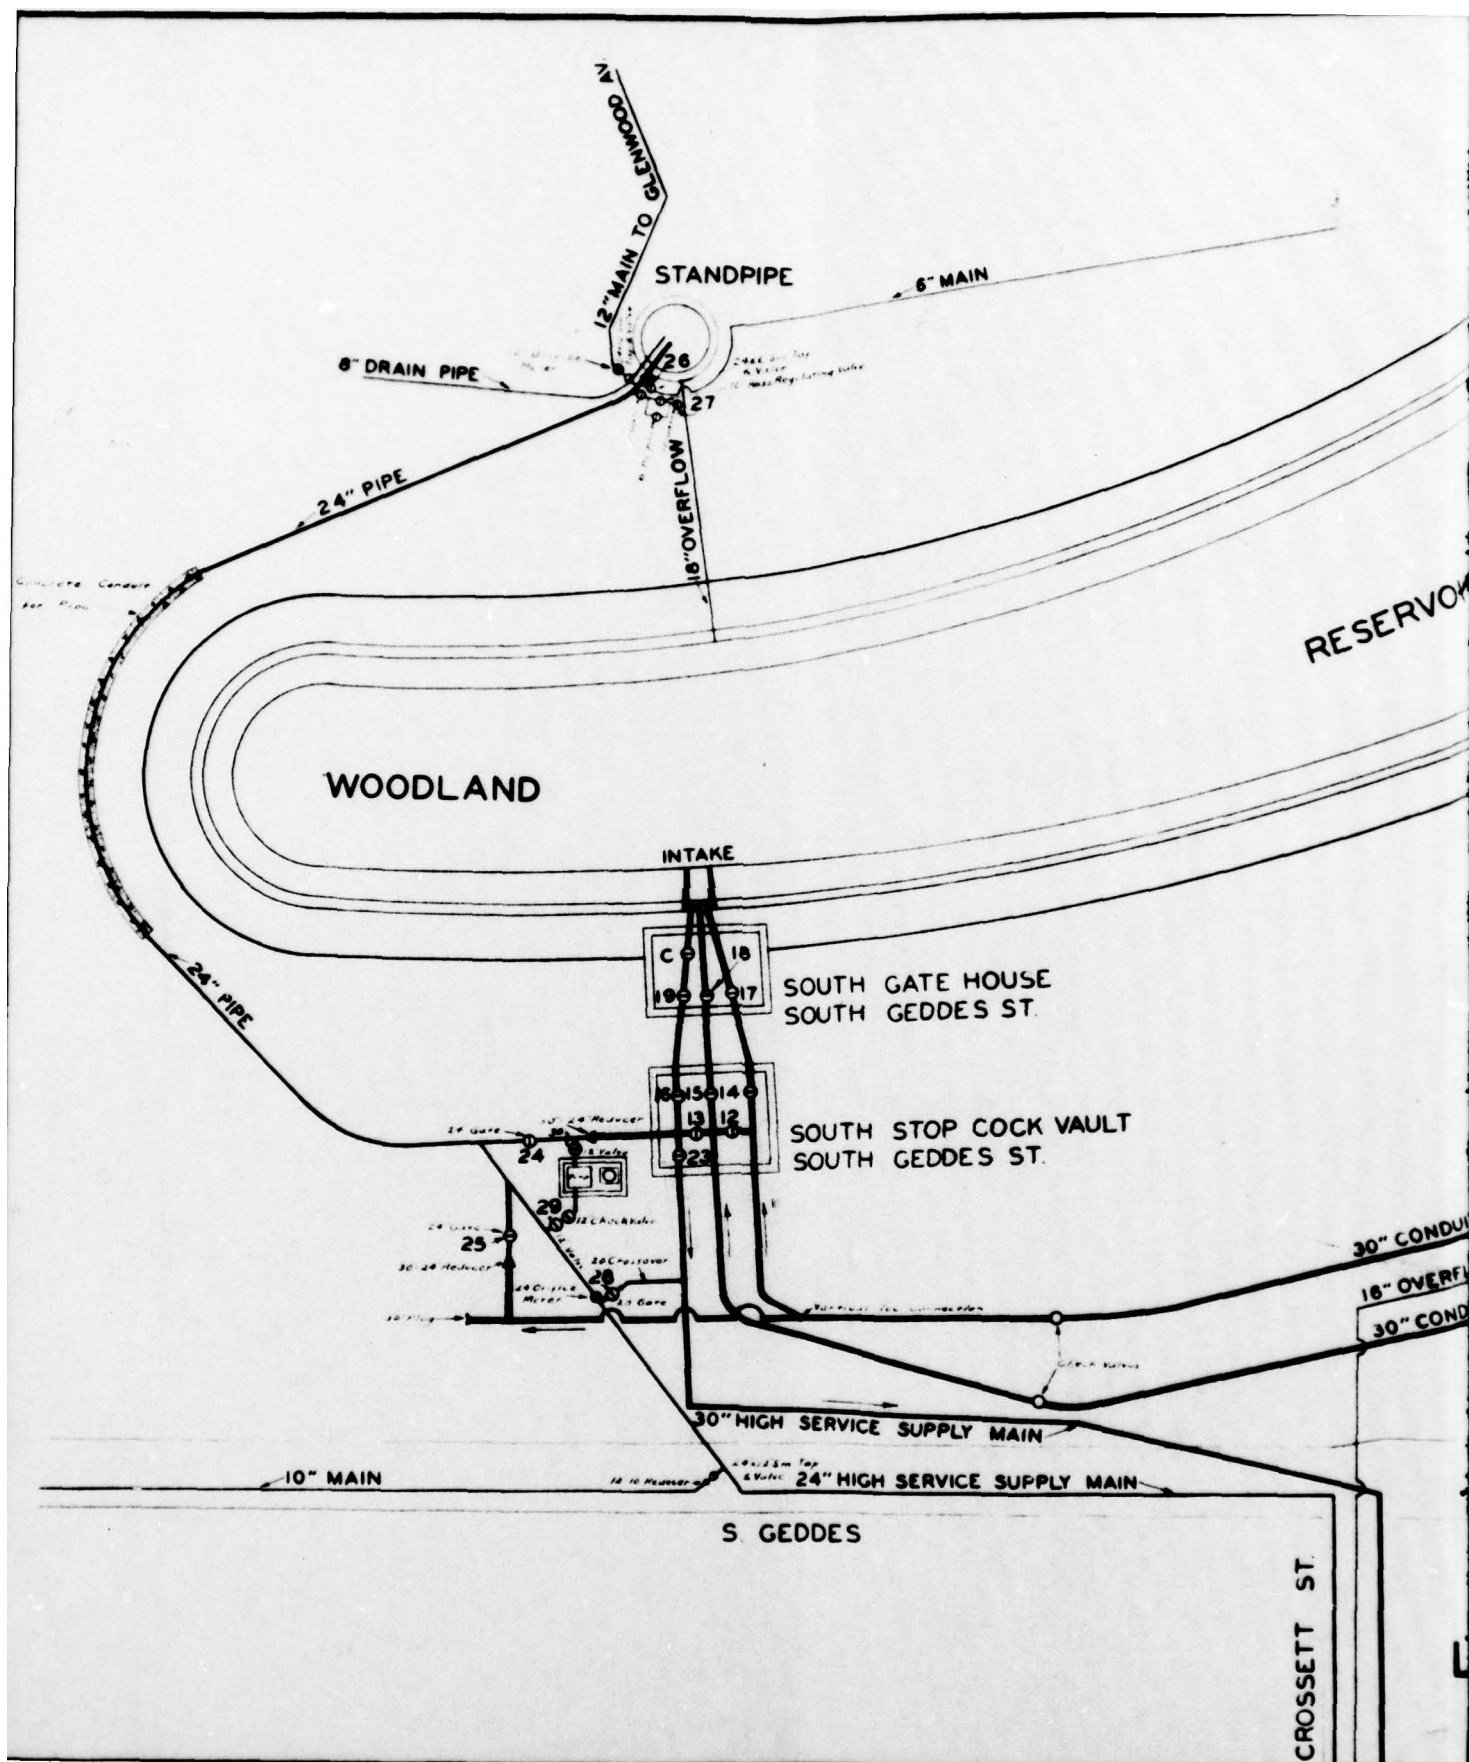
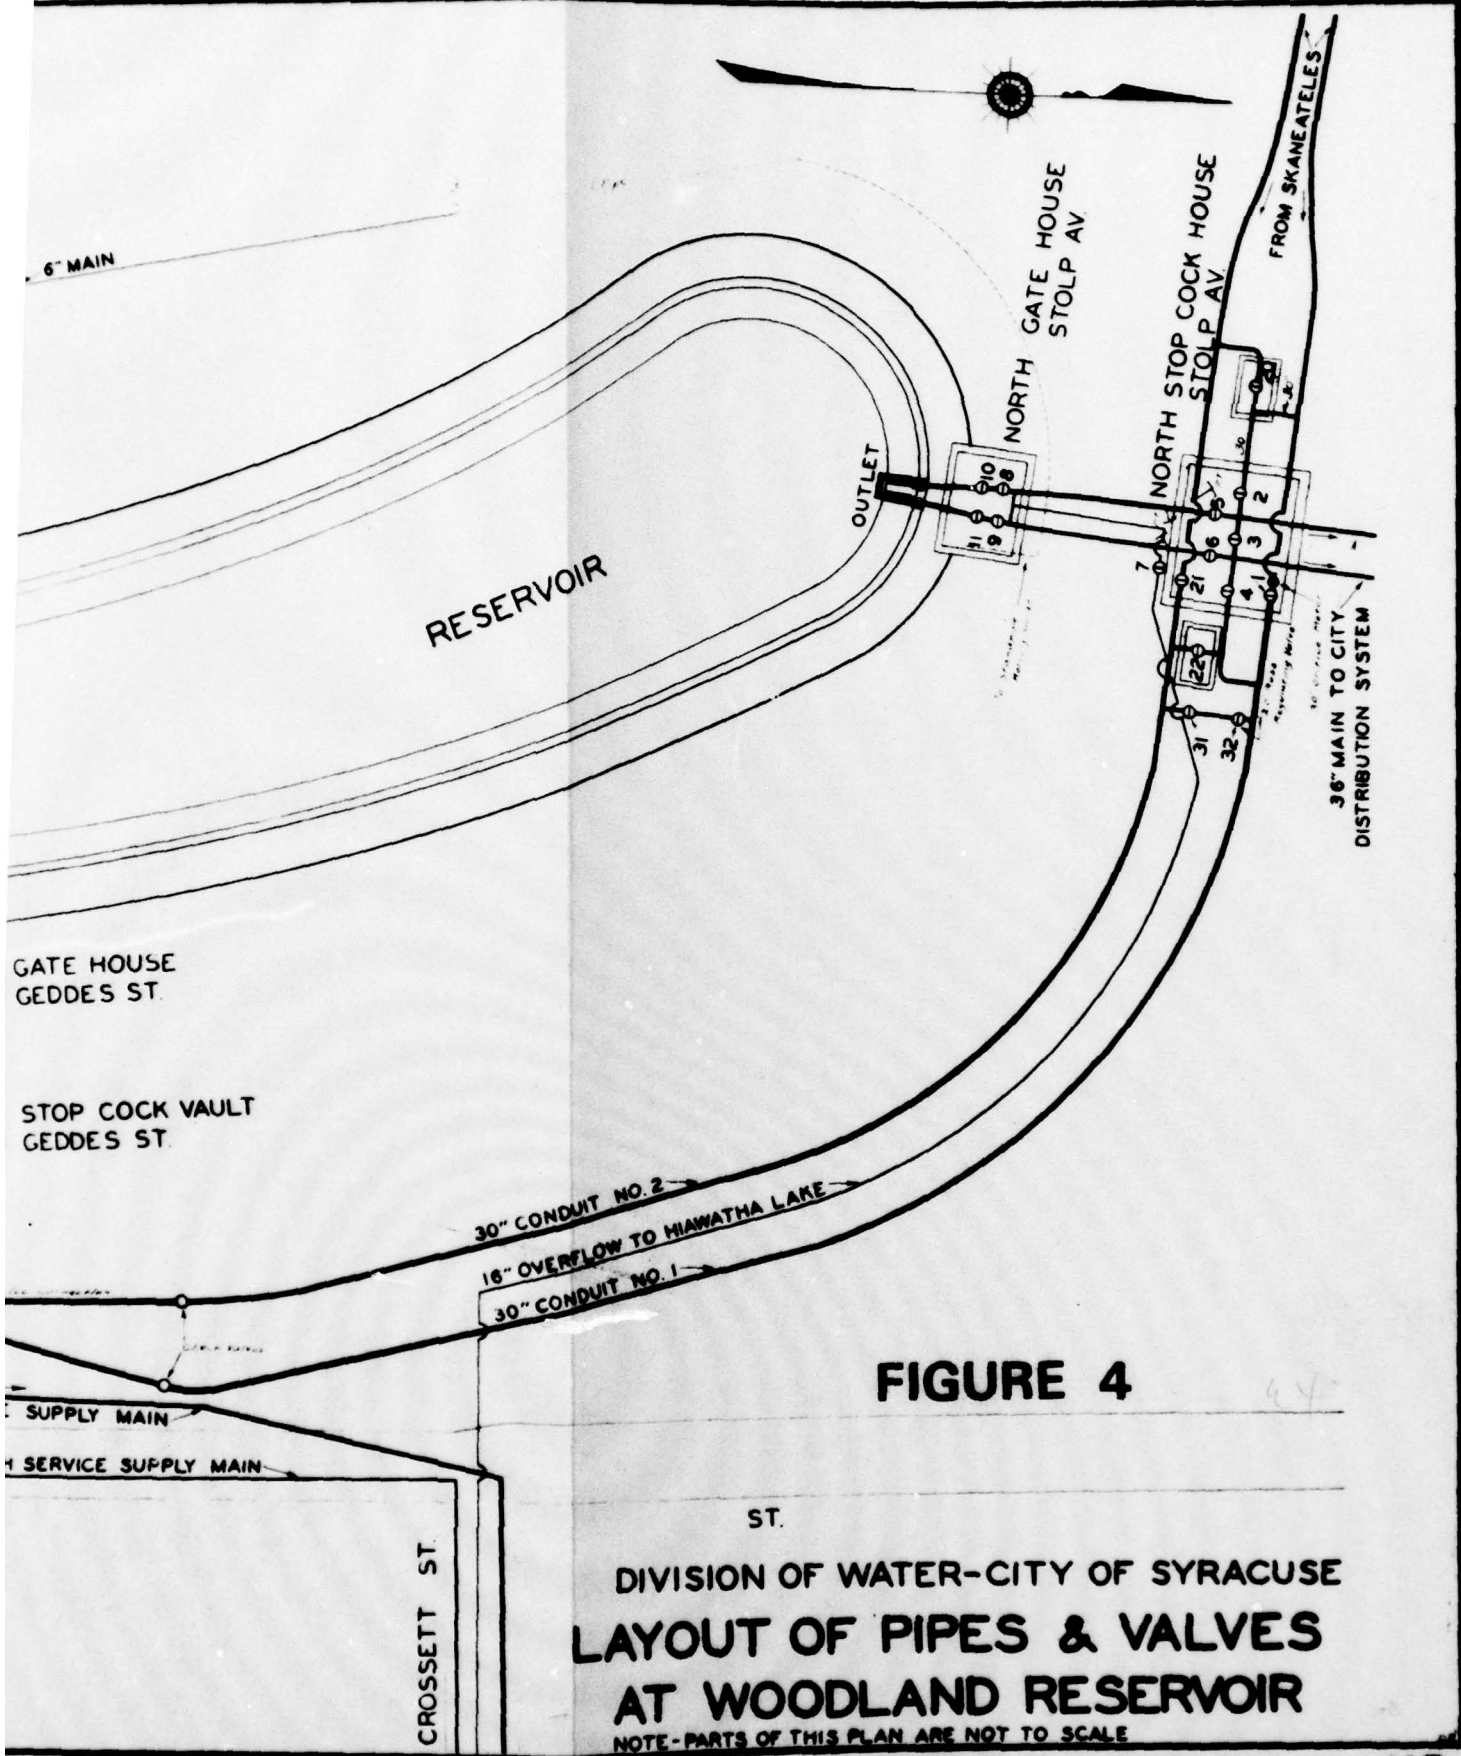
FIGURE 4

The intake structure and South Gatehouse are located at the southeast end of the reservoir. In addition, a control structure for the supply conduits is located below the base of the dam, near each of the two gatehouses. (See Figure 4 for details of the pipe and valve layout.)
